Ring Joint Flange Inspection

Problem: Inspection for cracking in the ring joint area of the flange.

Technique: The application of an ultrasonic method applying a pitch-catch technique assisted by a simple manipulator.

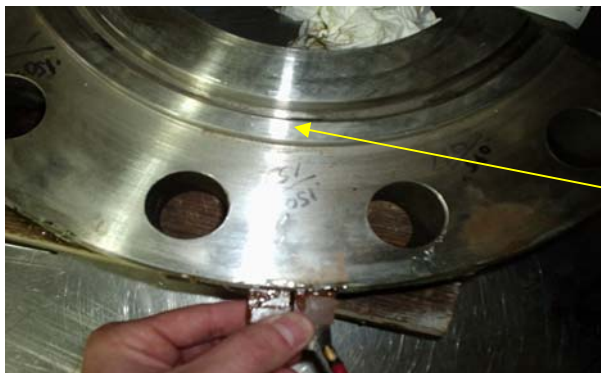
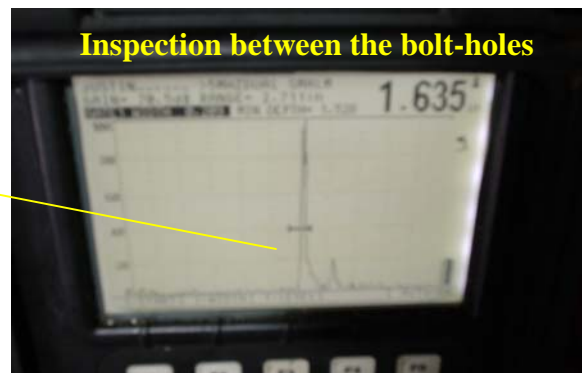
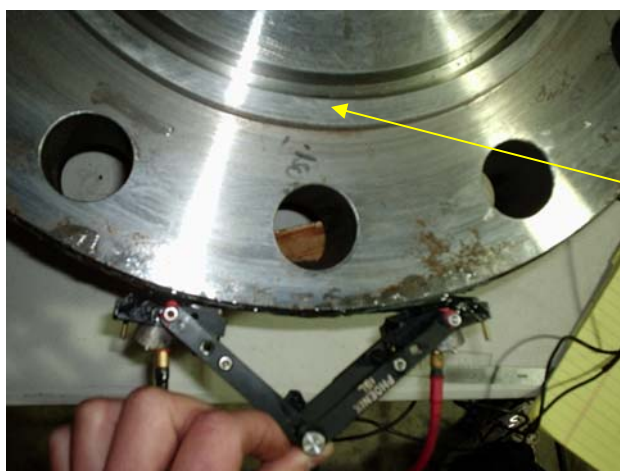
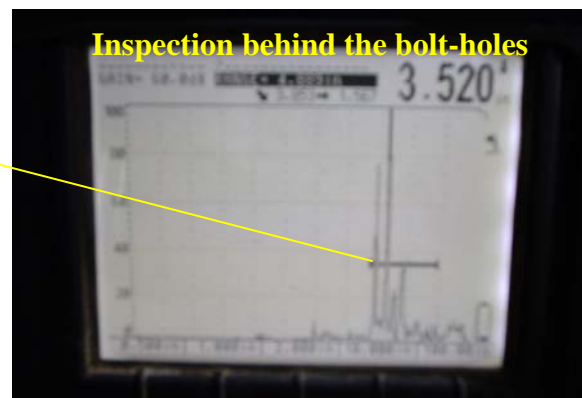
Two, 1/2 “, 5 MHz, composite probes are mounted special low angle shoes to look at the specified

Calibration: Longitudinal ultrasonic transducers are used with calculated probe roof angles. The roof angles are optimized for the range of the sound depending on the diameter of the flange being inspected. Special consideration has been made to adjust the angle such that cracks behind the bolt-holes are readily detected.
